Port of Portland

Date: September 23, 1994
To: George McShea
From: Bernie Butler *BMB*
Subject: AUDIT REPORT - WEST STATE INC.

APPENDIX A
SITE RECONNAISSANCE PHOTOGRAPHS

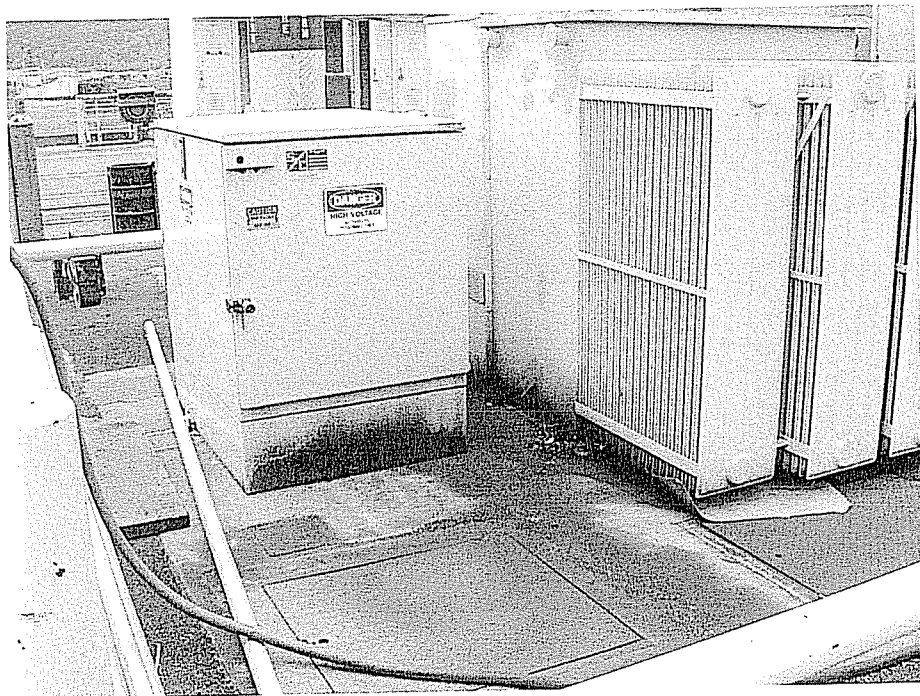
Photo No. 1

Description: Looking southwest at an oil leak from a transformer in Substation 8A.

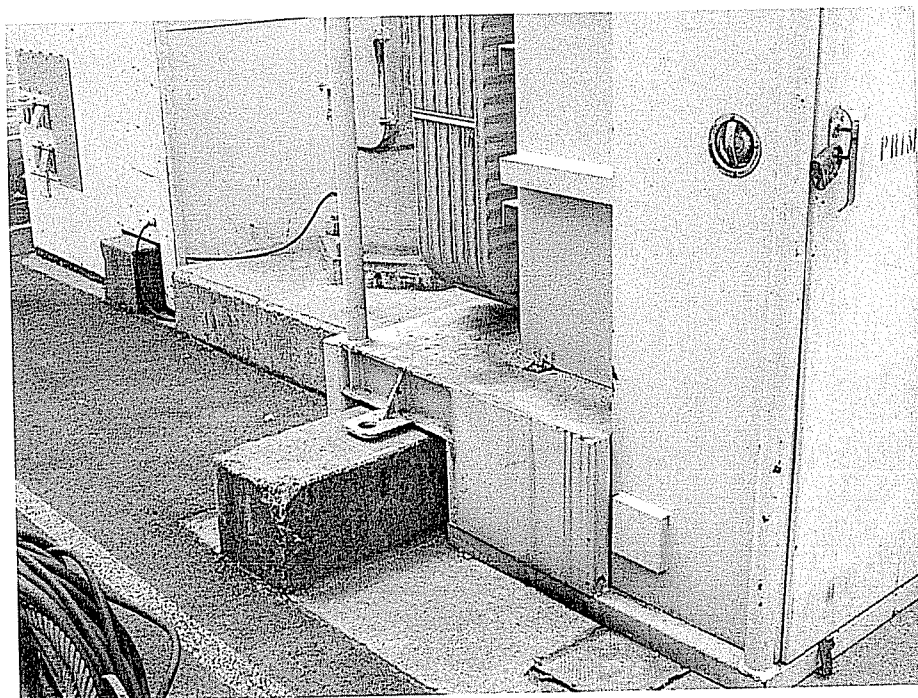
Photo No: 2

Description: Looking southwest at an oil leak from Transformer 4-3 near Berth 314/313

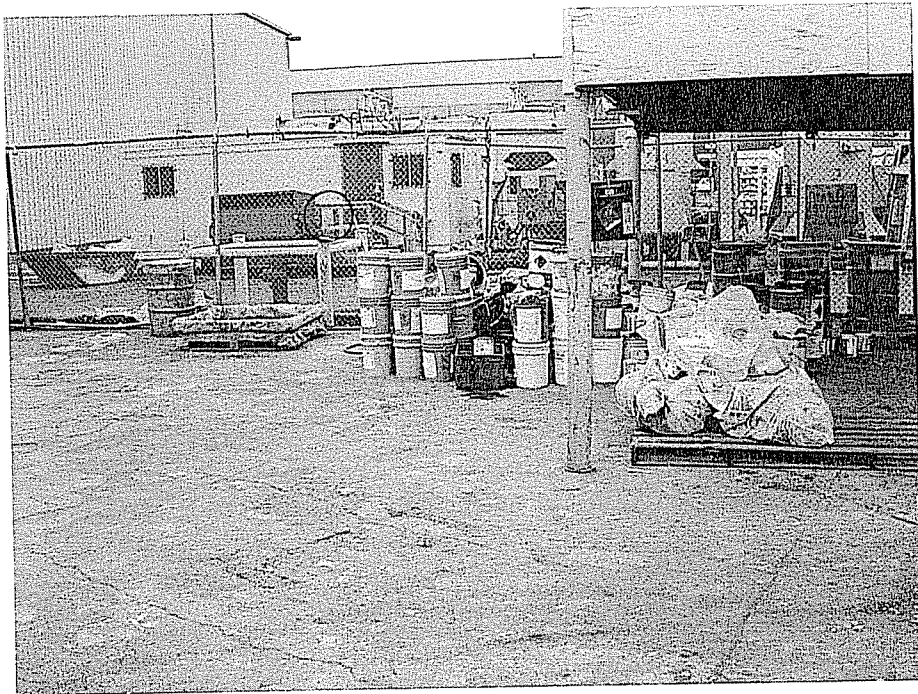
Photo No. 3

Description: Looking north at staining on asphalt in paint storage area adjacent to Building 73

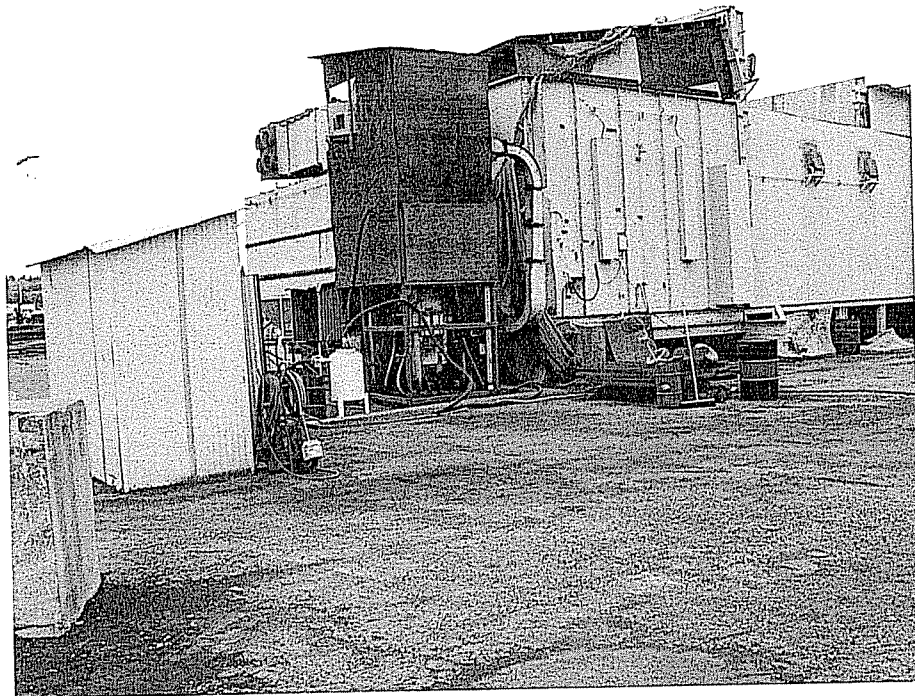
Photo No: 4

Description: Looking north at oil staining on asphalt near the west end of the sandblast booth near Building 73

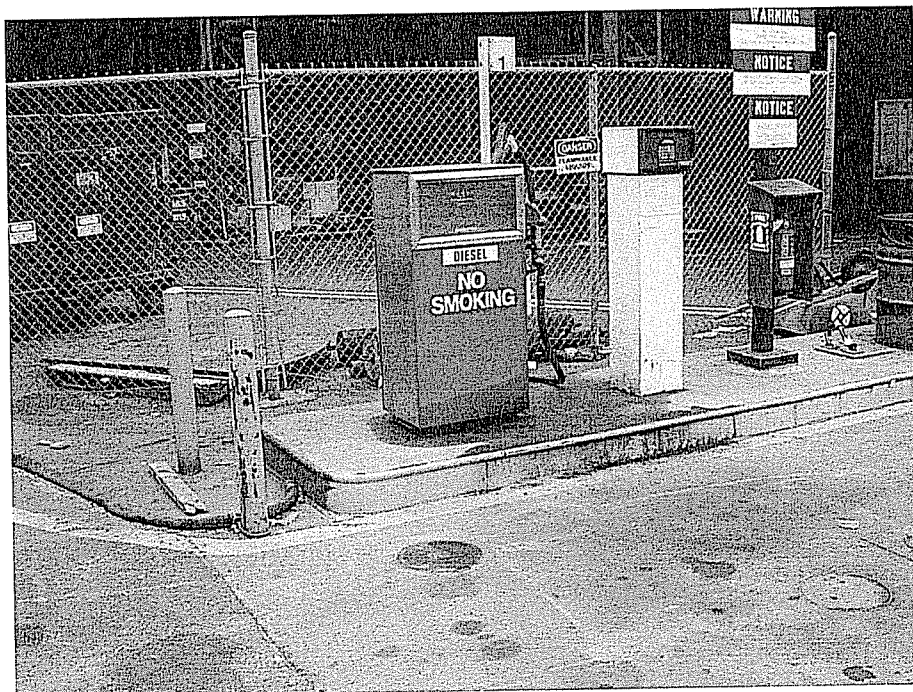
Photo No. 5

Description: Looking east at leaking diesel fuel pump in the Card Lock Fuel System

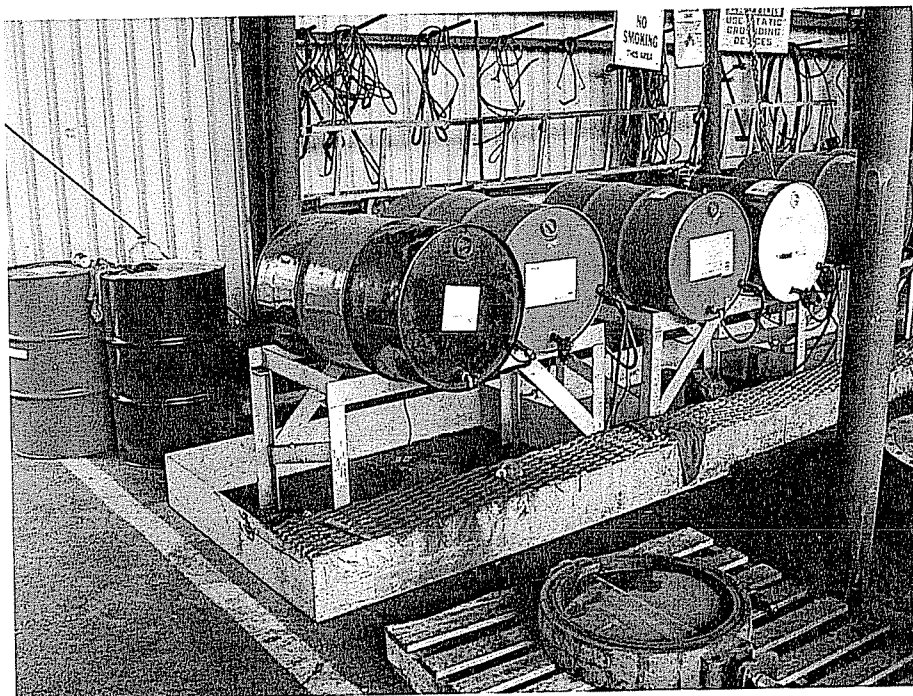
Photo No: 6

Description: Looking at staining on asphalt beneath rack used to 55-gallon drums of solvent, oils and kerosene near Building 63

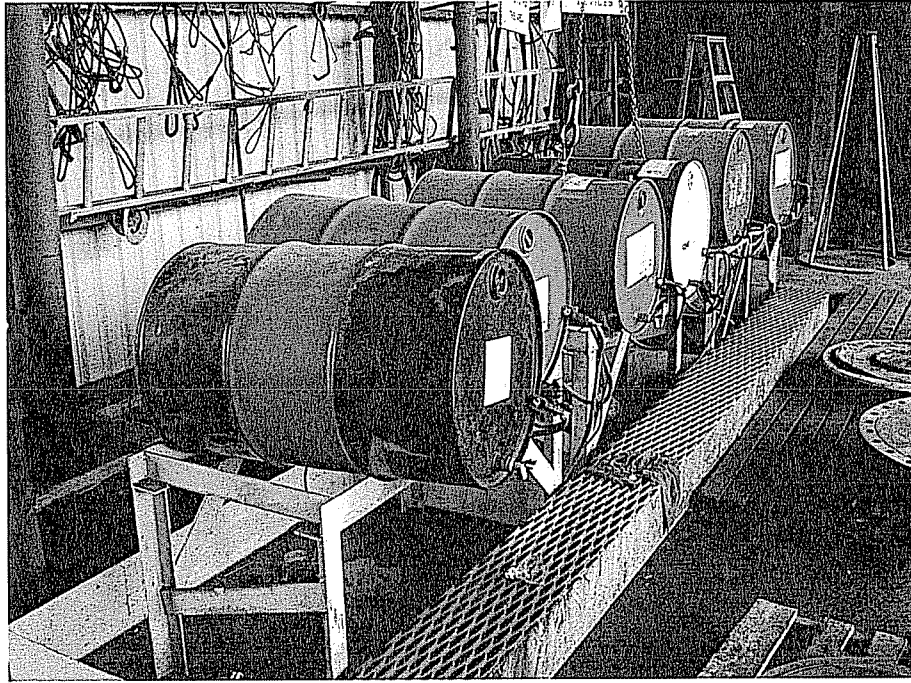
Photo No: 7

Description: Looking at 55-gallon drums on rack near Building 63

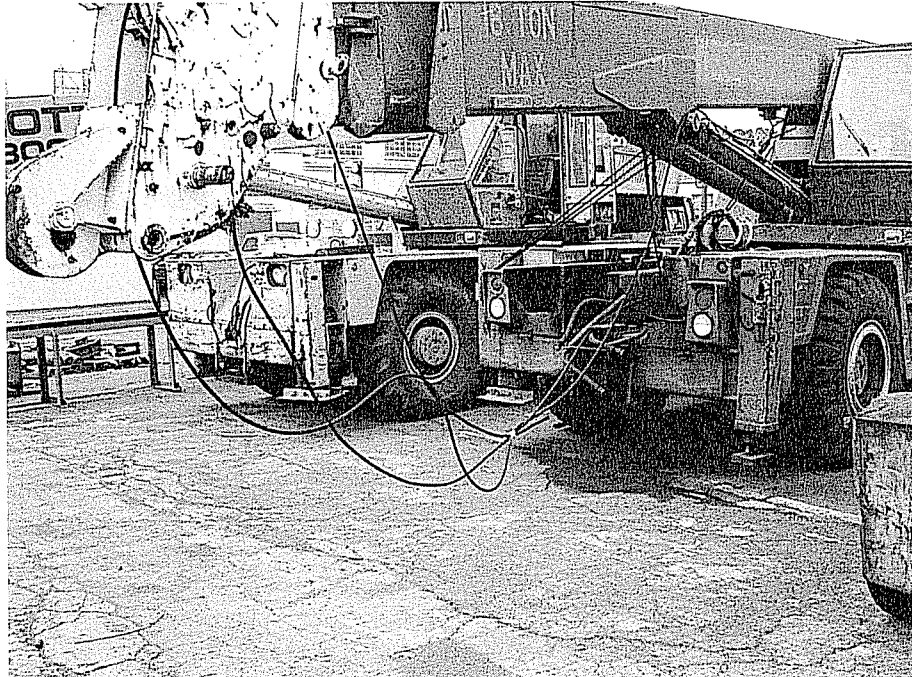
Photo No: 8

Description: Looking northwest at staining on asphalt beneath old equipment staged west of Building 10

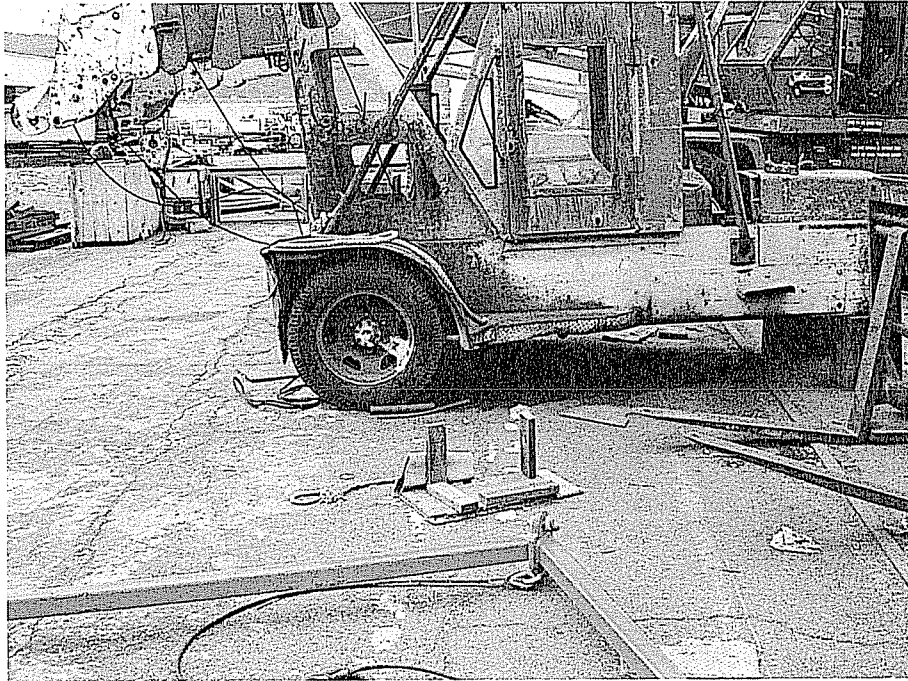
Photo No: 9

Description: Looking west at staining on asphalt beneath old equipment staged west of Building 10

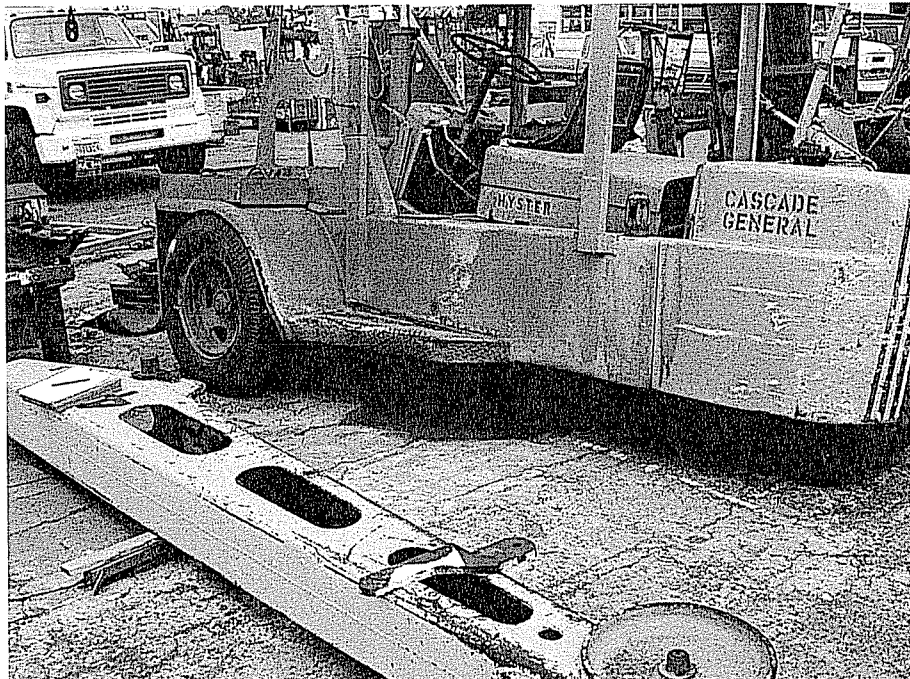
Photo No: 10

Description: Looking north at staining on asphalt beneath old equipment staged west of Building 10

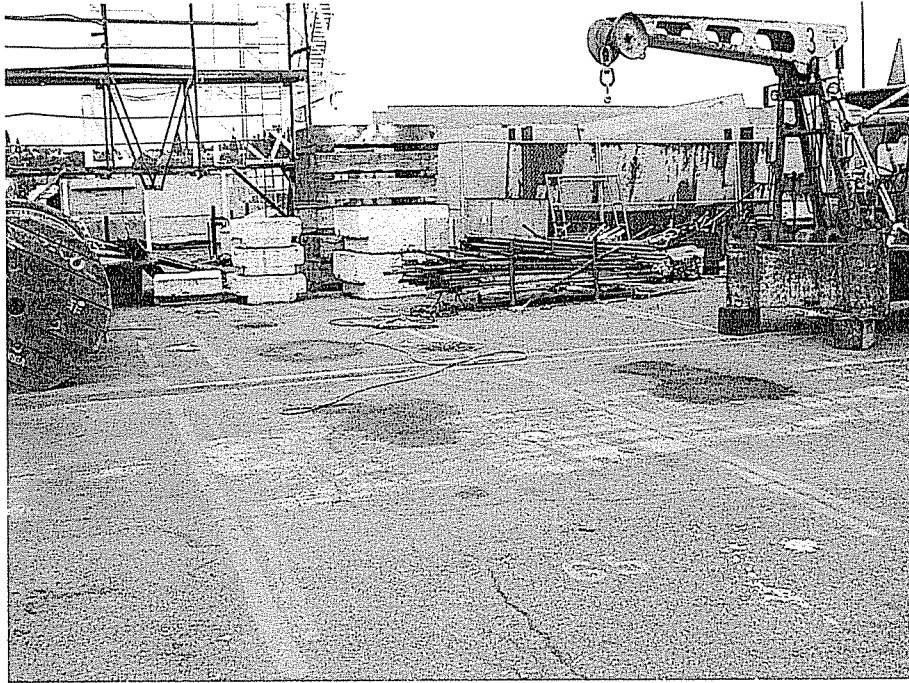
Photo No. 11

Description: Looking northwest at staining on asphalt beneath equipment staged west of Building 10

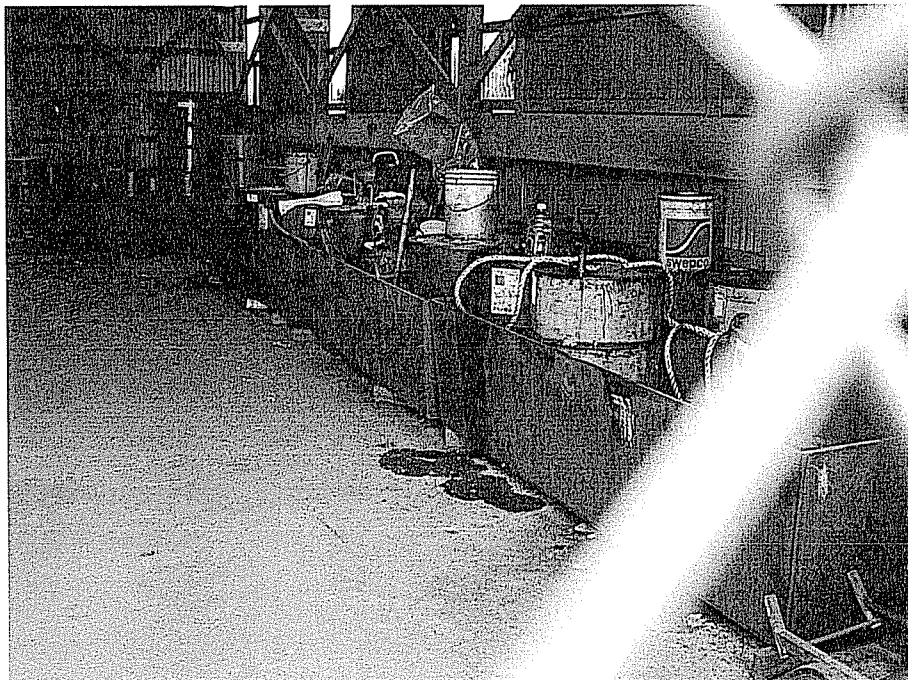
Photo No: 14

Description: Looking at staining on concrete floor in Cascade General's chemical storage shed

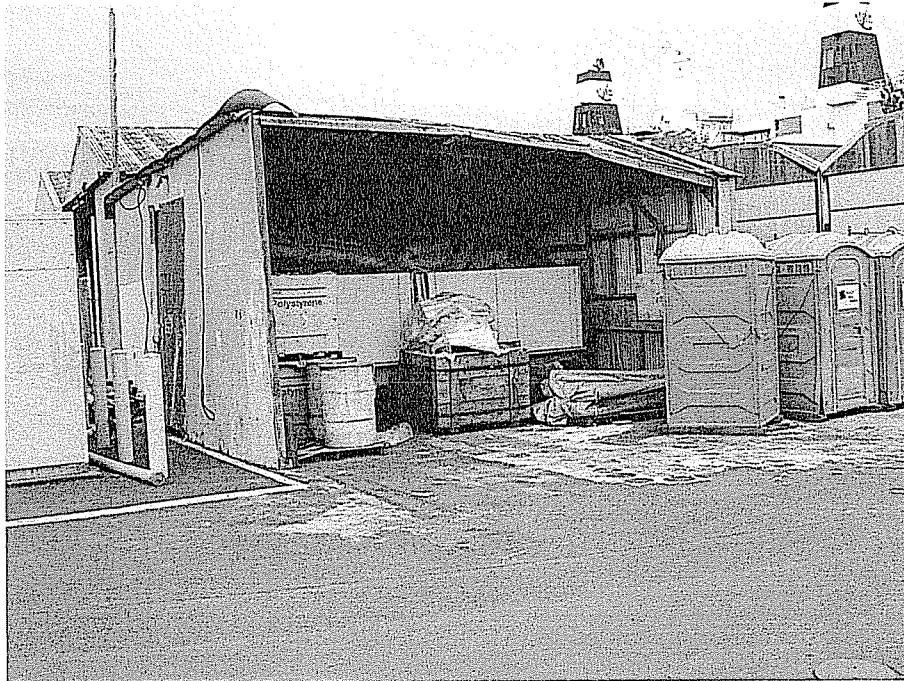
Photo No. 15

Description: Looking north at spilled paint on asphalt near Cascade General's spill equipment storage shed

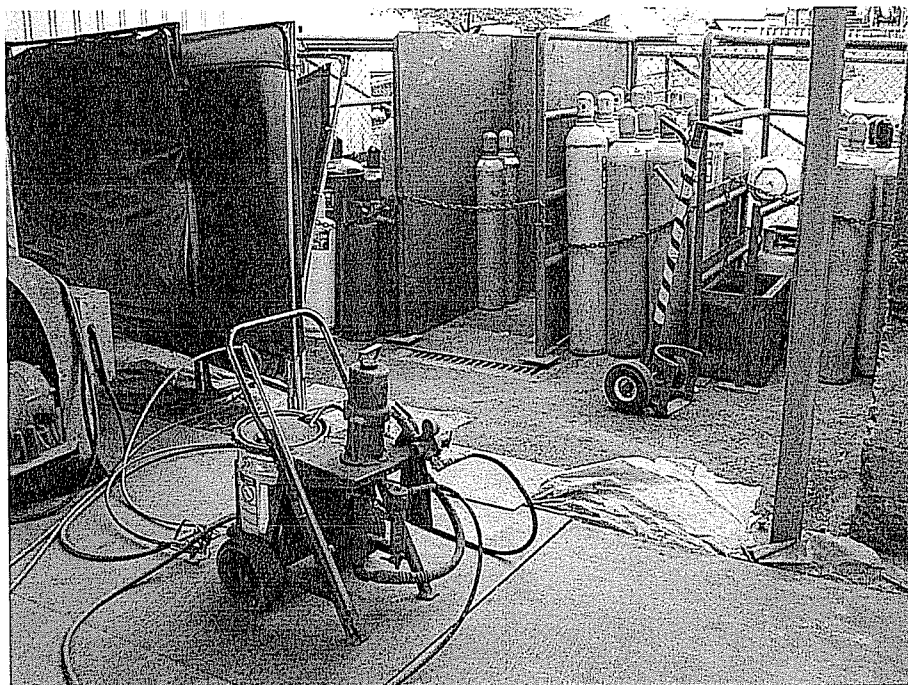
Photo No: 16

Description: Looking north at storm drain near the northeast corner of Bay 1, Building 4 where painting has been performed outdoors

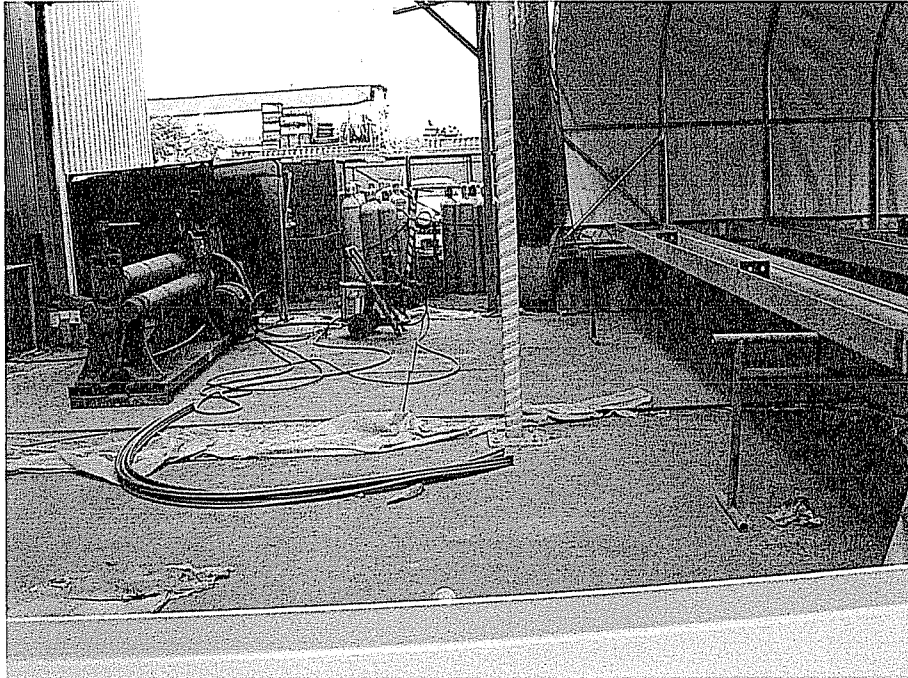
Photo No: 17

Description: Looking north at storm drain near the northeast corner of Bay 1, Building 4 where painting has been performed outdoors

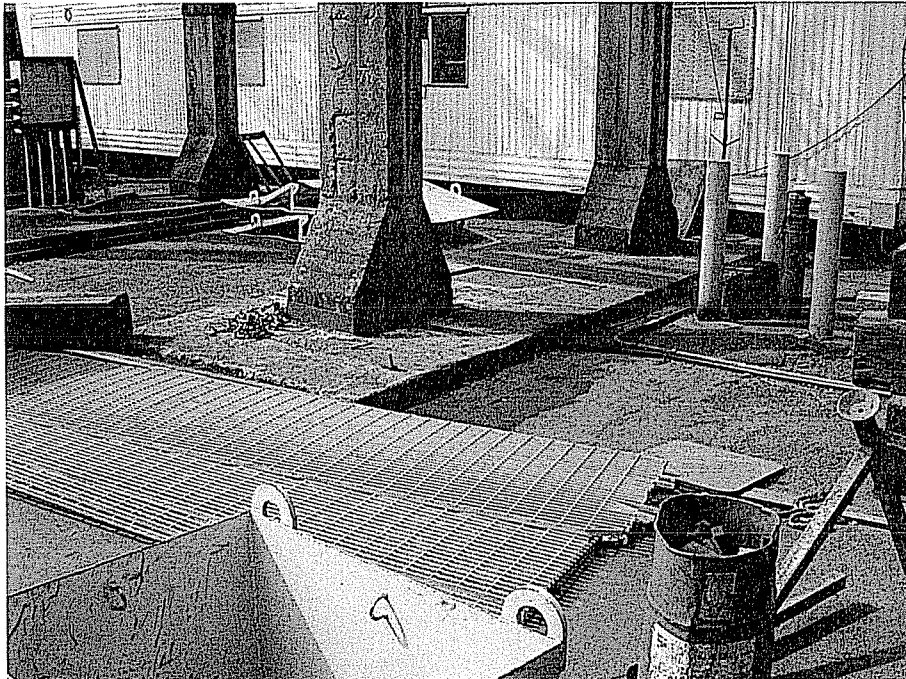
Photo No: 18

Stained asphalt was observed near the entrance to Bay 9 of Building 4 (see Photo No. 18). Within Bay 9, the concrete beneath many pieces of metal fabrication equipment (e.g., press, break, shear and roller) – see Photo No. 19. Oil leaks from several of the pieces of equipment appeared to be recent and ongoing.

Description: Looking north at staining on asphalt near the entrance to Bay 9, Building 4

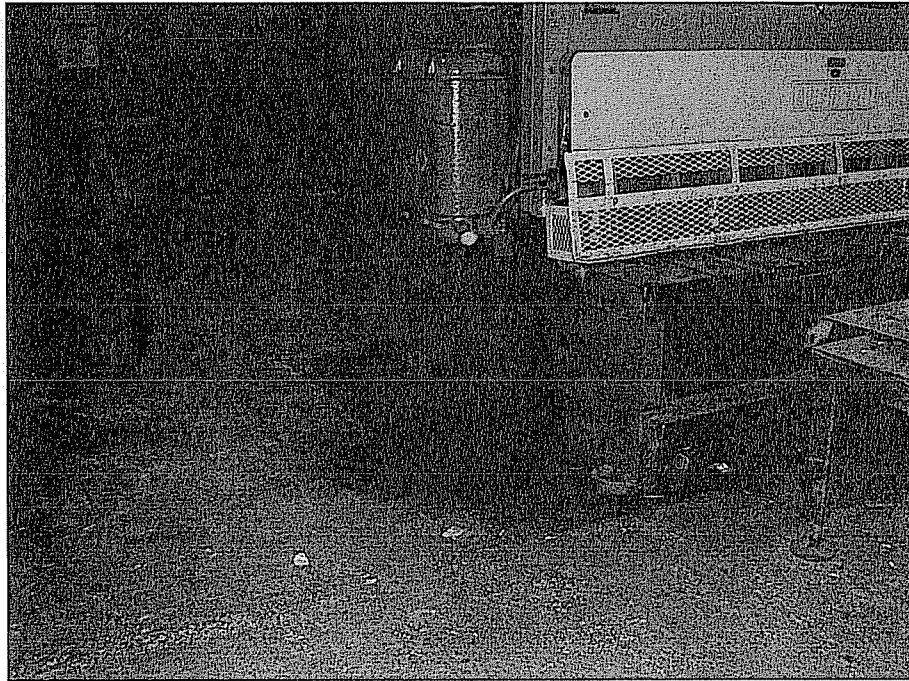
Photo No: 19

Description: Looking at staining on concrete beneath metal fabrication equipment in Bay 9, Building 4
